127th St and Pulaski Rd
<Westbound>

Village of Alsip

Initial Analysis
with 24hr Video Traffic Study
Aug 2017

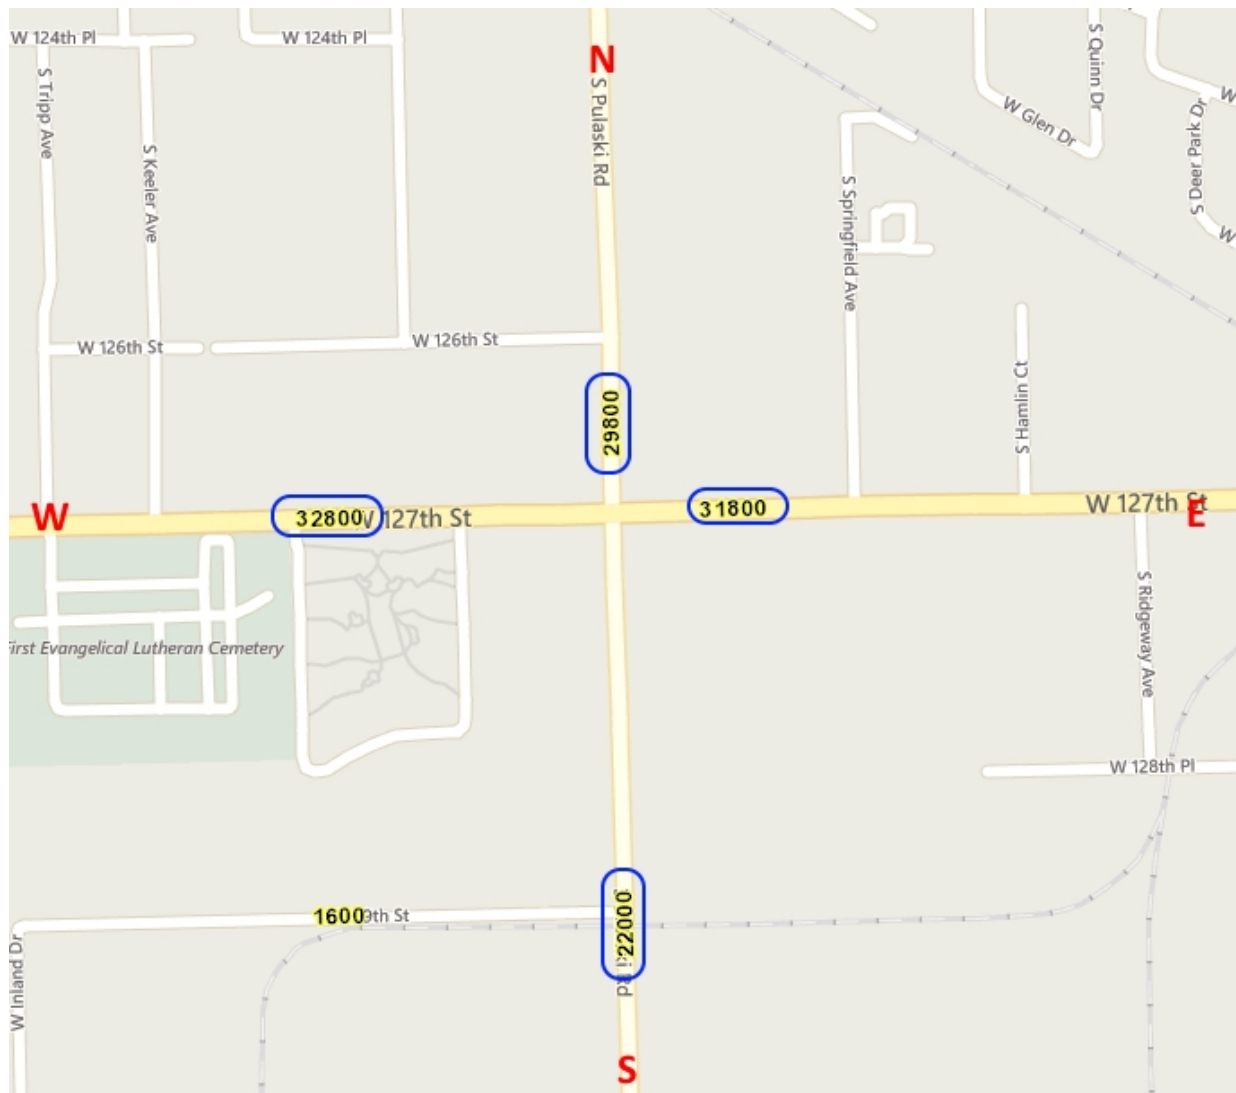
B. Average Daily Traffic Count

The following information was obtained via the Illinois Department of Transportation website per the RLR Guideline document published by IDOT. Only ADTC values were available, peak numbers were not provided.

Pulaski Rd ADTC

- North - 29,800
- South - 22,000

127th St ADTC

- East - 31,800
- West - 32,800

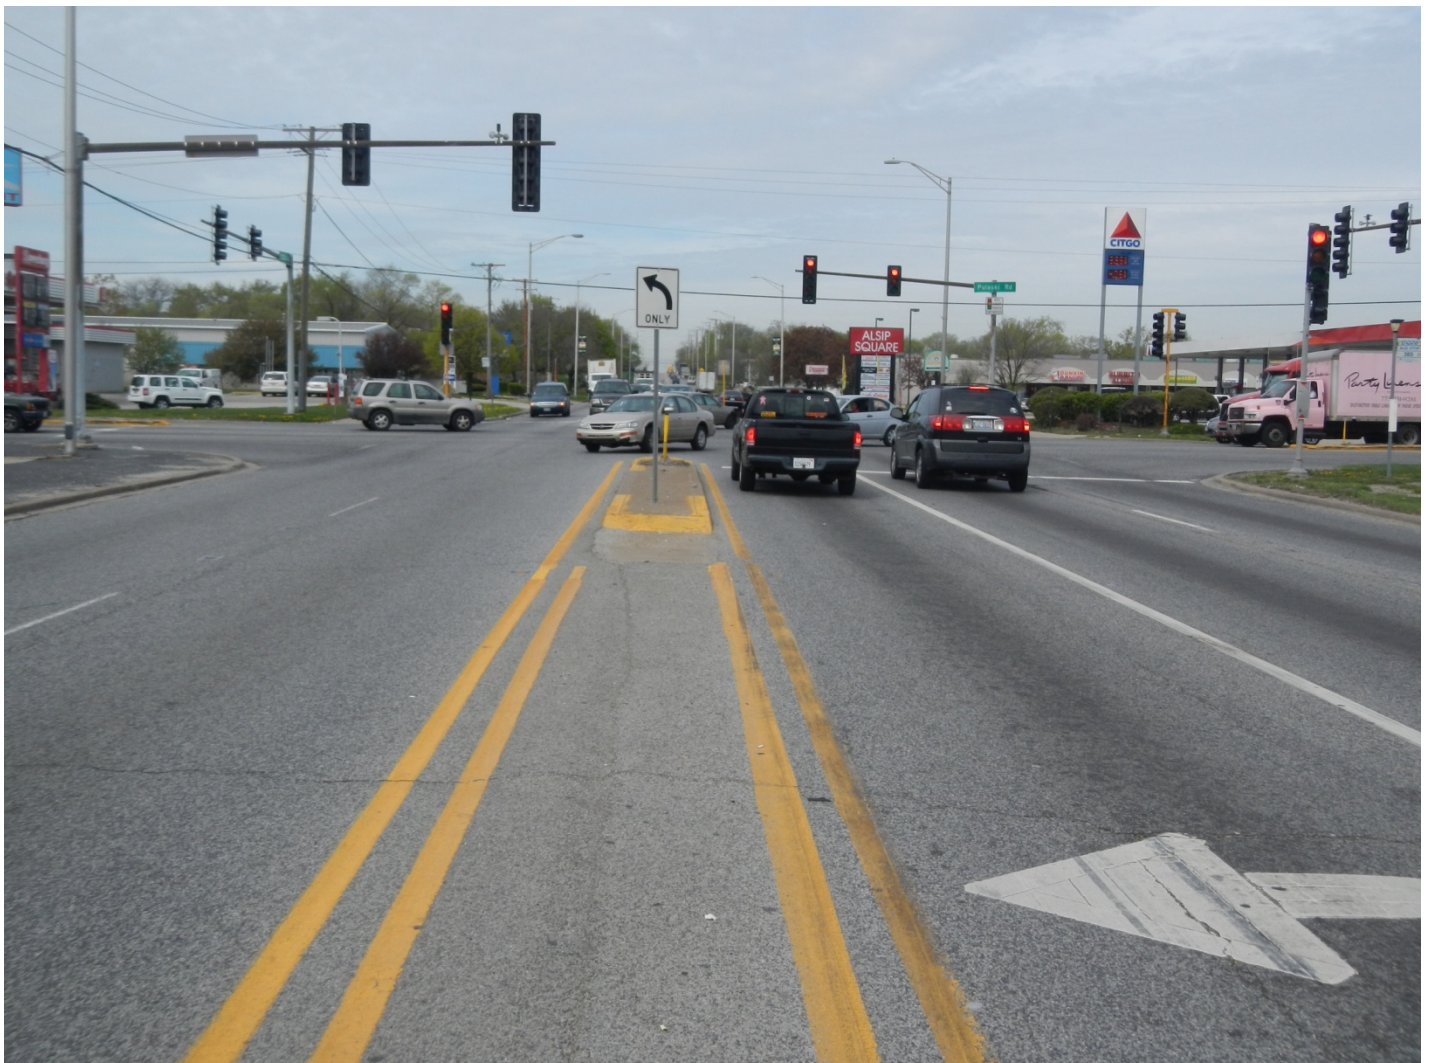
Westbound 127th St and Pulaski Rd

- Traffic controller box is installed at Southeast corner
- Bus Stop (10')
- No Cross walk
- 3 lanes
- Dedicated left turn lane
- No Sidewalk
- 4 traffic lights
- Speed Limit: 40 mph
- Possible Location: ~60ft from the Stop bar (where the existing RLR camera is located)

SafeSpeed, LLC, recommends going forward with the vendor transfer process on the following approach(es):

- 1. 127th St and Pulaski Rd (Westbound)**

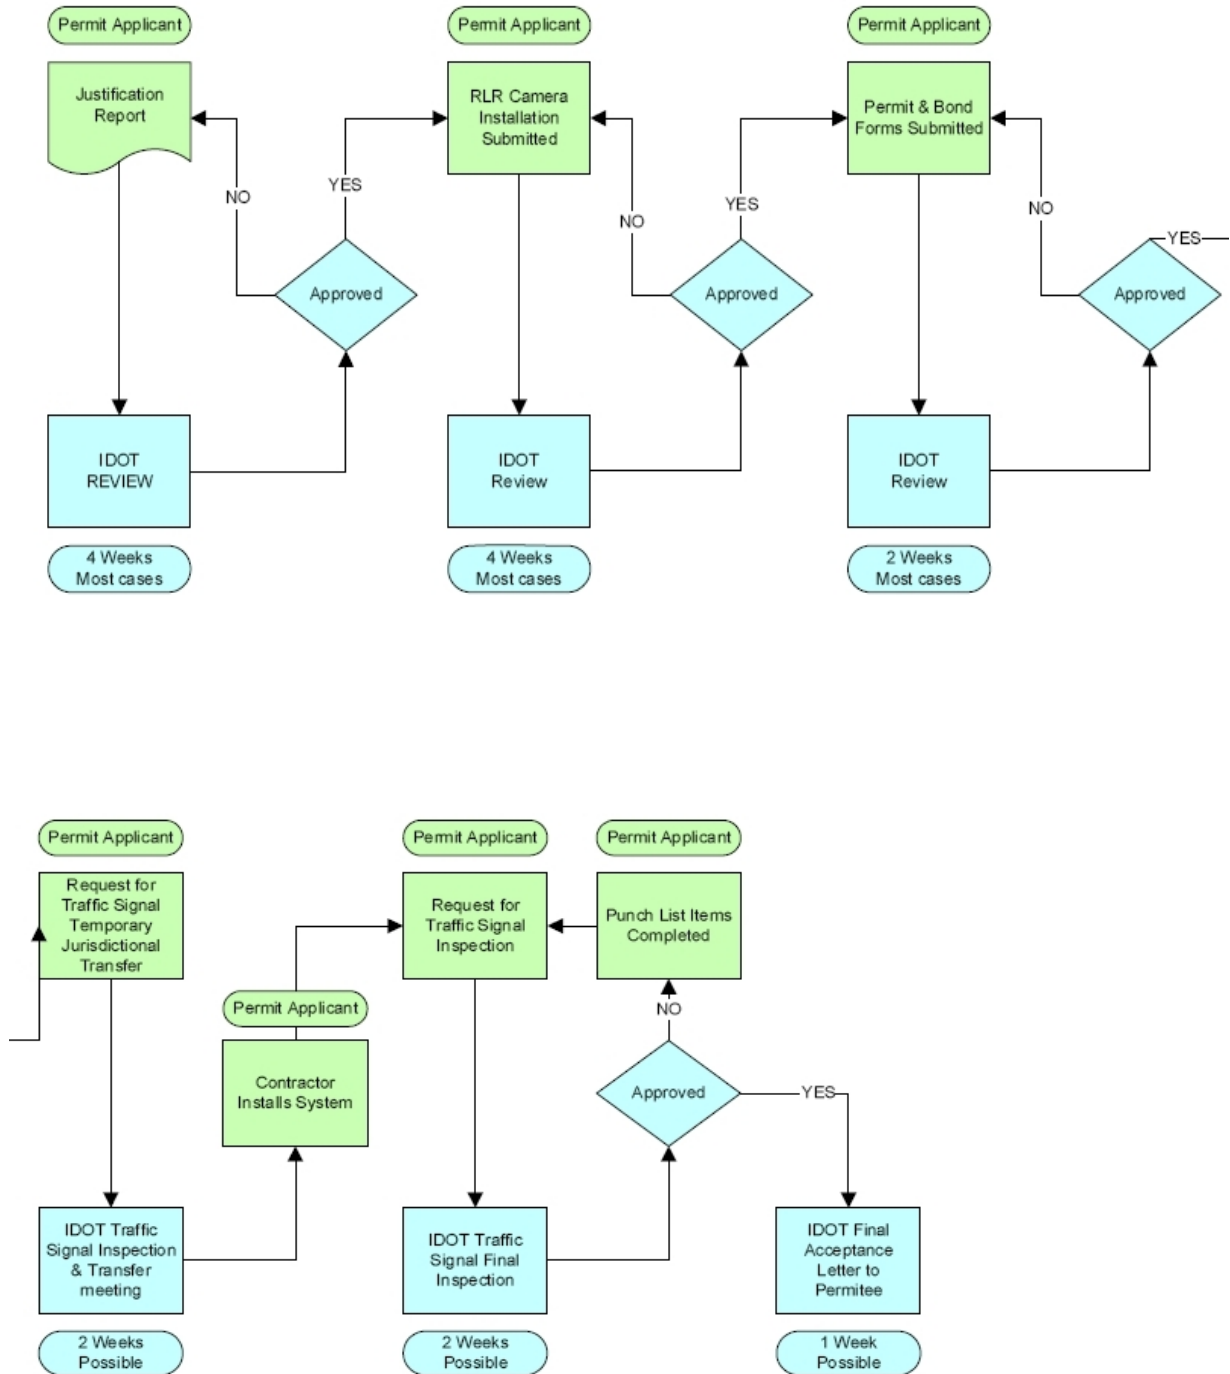
Illinois Department of Transportation Red Light Running Process Flow Chart

The next page shows the general RLR permit process flow chart provided by IDOT.
